## INCONEL 625 VALVE SEAT HARD FACING MATERIAL

### Background

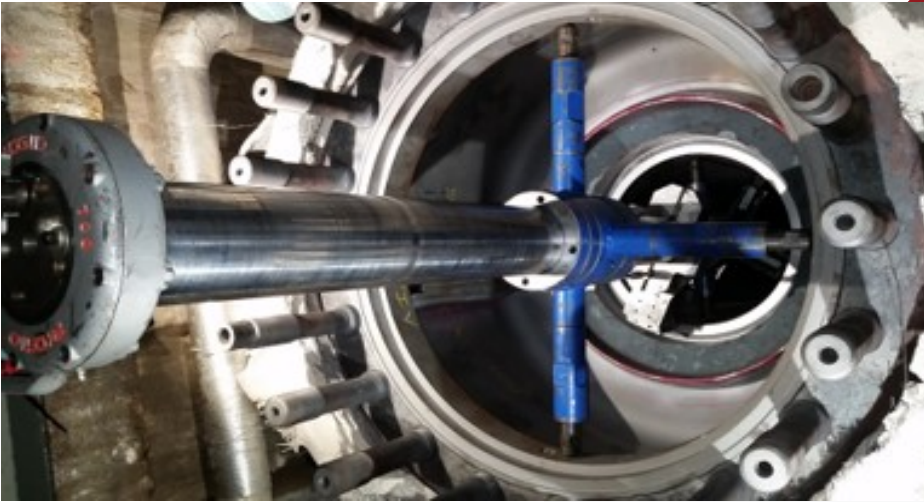
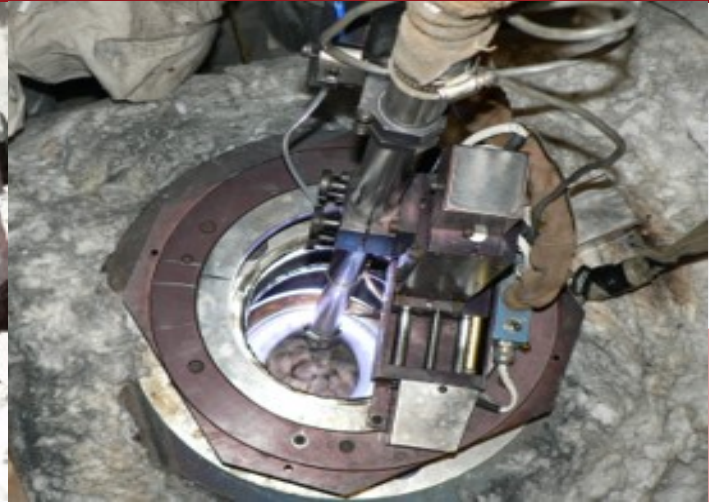
Fast acting steam turbine valves, increased temperatures and vibration create significant operational challenges for valve seat components, thus leading to delamination of the CoCr layer from the high Chromium (9%-12% Cr) base material.

Delaminated seat particulates have been responsible for downstream damage of the steam path.

Studies into the root cause of the problem identified the different heat expansion coefficient combined with the Heat Affected Zone (HAZ) of the base material and the overlay are the chief causes for the problem.
